Boeing 707 ZS-EUW

SOUTH AFRICAN AIRWAYS BOEING 707=344C AIRCRAFT

ZS-EUW, "PRETORIA", AT WINDHOEK ON

20TH APRIL, 1968.

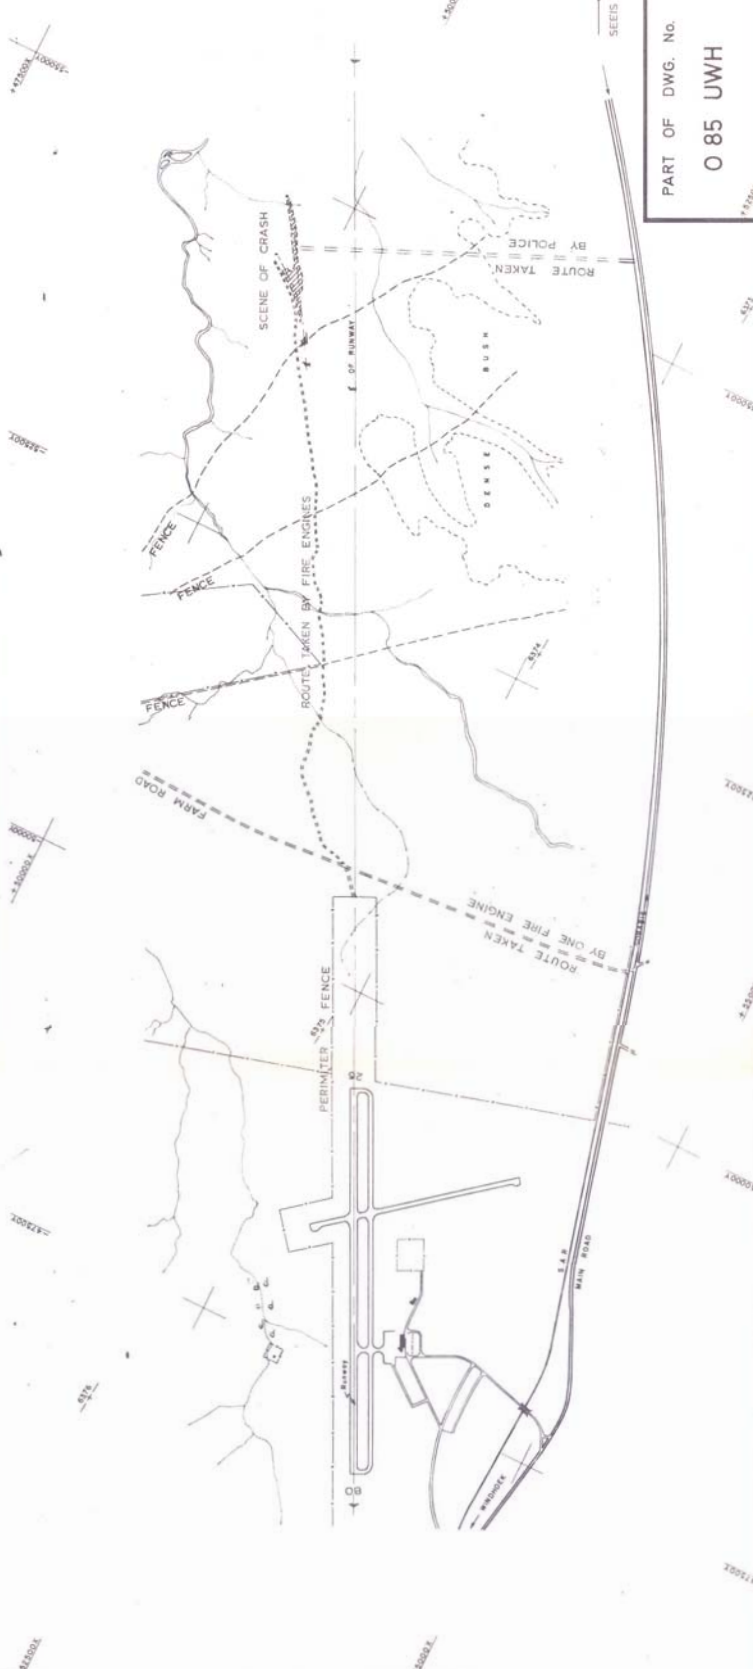
SITE PLAN

SCALE 1:25000

0 500 1000 2000 3000 METRES

PART OF DWG. No.

0 85 UWH
